# engine damage

## Case study 1

## Case study 2

## Case study 3

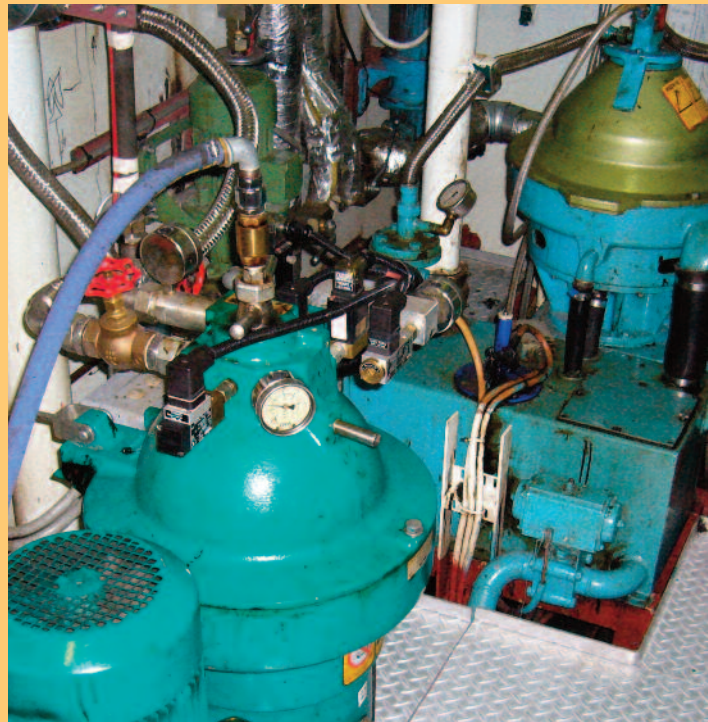
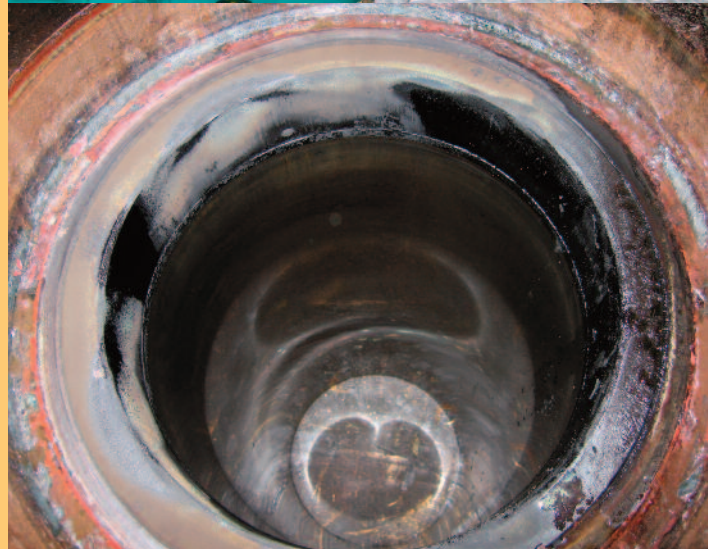
A few hours later I heard a knocking noise and saw a leak coming from the no. 2 cylinder cover on the no. 1 diesel generator. We were worried that the valves were misaligned and so we shut down the diesel generator and stopped the main engine.

**“A few hours later I heard a knocking noise and saw a leak coming from the no. 2 cylinder cover on the no. 1 diesel generator.”**

The primary cause of the breakdown was failure of the purifiers. With both purifiers having damaged seals, it is highly probable that the impurities and water contained within the fuel oil were not removed before being burnt by the main engine and diesel generators. Finally, the purifiers were stopped and the vessel continued to consume the fuel without any purification. As a result, the engines were not able fully to burn the fuel being fed and suffered overheating and internal damage

To consume untreated heavy fuel is never a good idea. In hindsight, with the fuel treatment system out of order the engine crew should have immediately switched over to marine gas oil whilst the problem with the purifiers were rectified.
